# THE ANATOMY OF AN ICE DAM

*By Rick Quirouette, B. Arch.*

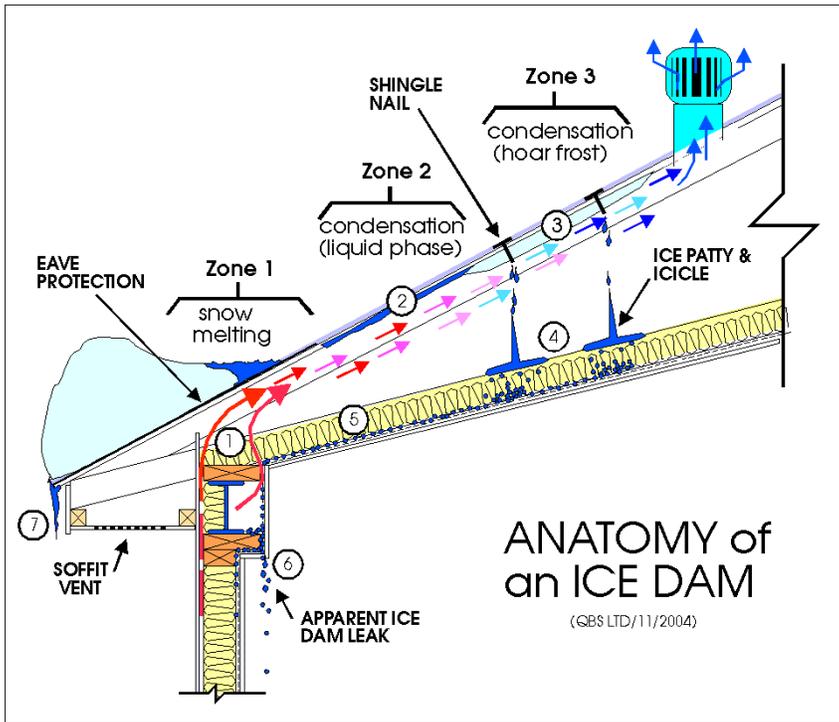
Starting at the top of the attic, it was noted that the turbine vent was clear and free of obstructions. At first the underside plywood appeared clean and dry but then as the investigator crawled lower into the truss cavity, towards the outside wall, a band of frost was noted under the plywood sheathing, about 1.5 meters wide. Further down into the attic cavity below the frost, the plywood sheathing was found wetted for about another 1.5 meters. Further down again, the plywood sheathing was found clean and dry at the truss connection to the outside wall. While probing with his hand, the investigator noted warm air rising at the exterior wall over the underside of the roof sheathing. The most startling observation was the discovery of inverted icicles and ice patties on the surface of the roof insulation. These were found mostly below the frosted area almost directly under the nails of the roof singles (see Figure).

The anatomy of this type of water leak appears to be as follows. During cold nights, at or below  $-20^{\circ}\text{C}$ , when stack effect is strong due to a large temperature difference, air exfiltrates into the attic through all the cracks and holes of the outside wall cavity to leak into the attic. The warm exfiltration air rises to wash over the plywood sheathing to melt some of the snow on the roof surface while losing some of its heat (1). Then, as the exfiltration air drift up toward the vent, it is further cooled by the plywood sheathing and now deposits condensation for about 1.5 meters up slope (2). Drifting

Lastly, because these buildings had sheet metal eave protection for about 2 metres up slope, the melting snow of the ice dam drained over the edge of the roof to form the icicles indicated in the diagram. It is important to note that the ice dam water did not penetrate to the inside in these buildings.

From the above observations, the ice dam water leaks were finally demystified. The actual cause of the roof/ceiling water leaks was not the external moisture of snow and ice but rather the accumulation condensation in the attic from the exfiltration of indoor air and the subsequent melting of frost and leakage of water to the inside.

further up slope of the sheathing, the exfiltration air now deposits its remaining moisture as frost for about another 1.5 metres. Beyond this point, the air exfiltrates through the turbine vent completely dehydrated and dry (3).

The next part of the cycle takes place in the daytime when the outside temperature rises slightly but not above freezing. On clear, cold sunny days, the sun warms the black exposed shingles and plywood on the up slope portion of the roof where there is little snow. This causes the underside frost to melt and to drain downward to a roof nail and then to drip down over the insulation below. Because the surface temperature of the insulation is still well below freezing, the dripping water splashes into a patty of ice with an inverted icicle forming above (4). There were well over 20 such patties of ice observed on the surface of the insulation that night.
