# Commissioning of Exterior Building Envelopes of Large Buildings for Air Leakage and Resultant Moisture Accumulation using Infrared Thermography and Other Diagnostic Tools

Mario D. Gonçalves, Patenaude-Trempe<sup>1</sup>  
Pierre Gendron, Patenaude-Trempe<sup>2</sup>  
Tony Colantonio, PWGSC<sup>3</sup>

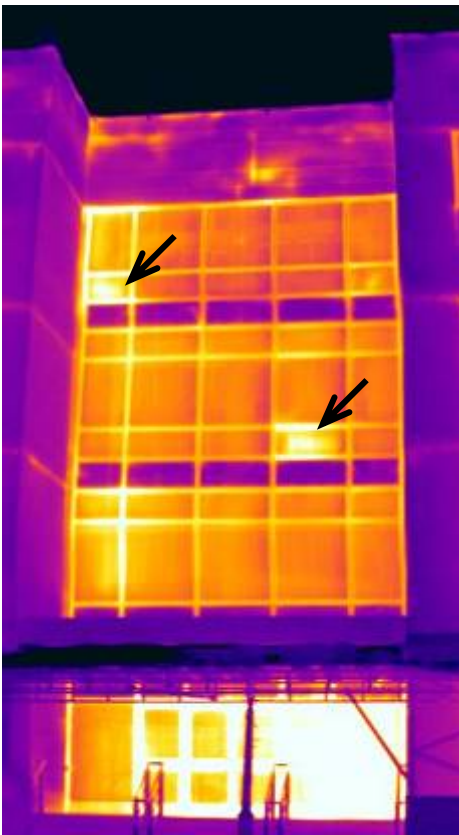
**Figure 1:** What may appear to be a thermal anomaly in the curtain wall assembly is visible in this exterior thermogram (building under positive pressure).

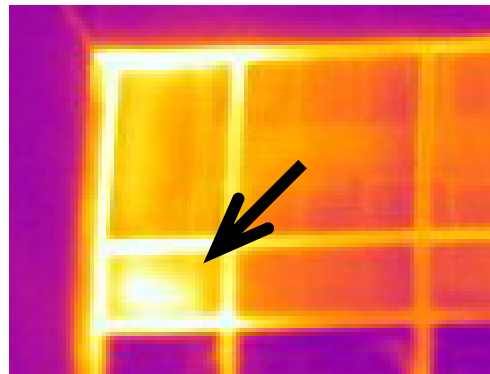
**Figure 2:** Close-up view of figure 1.

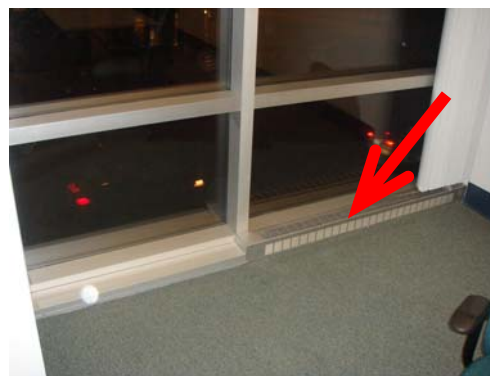
**Figure 3:** An interior heat source located directly against the interior side of the CW assembly yields misleading results.

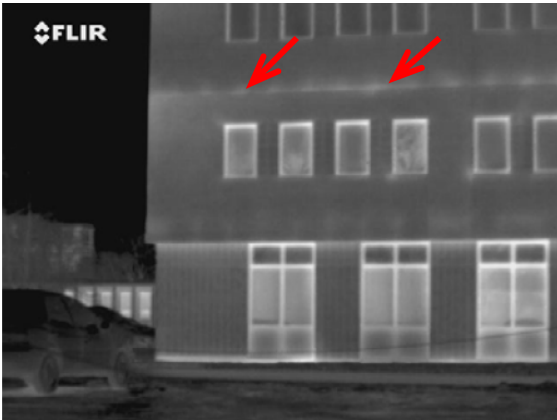
**Figure 4:** Conductive heat loss at masonry structural shelf angle support (building under positive pressure).

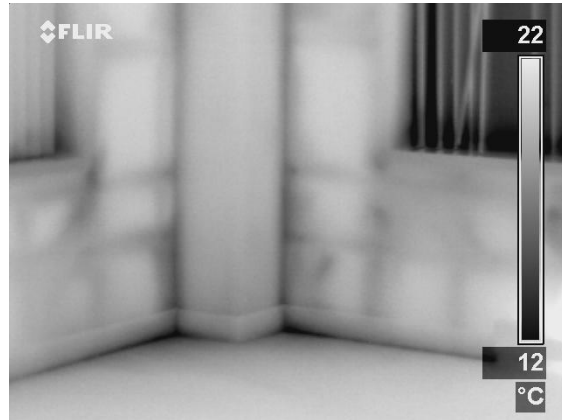
**Figure 5:** Convective heat loss pattern noted below windows (building under negative pressure).

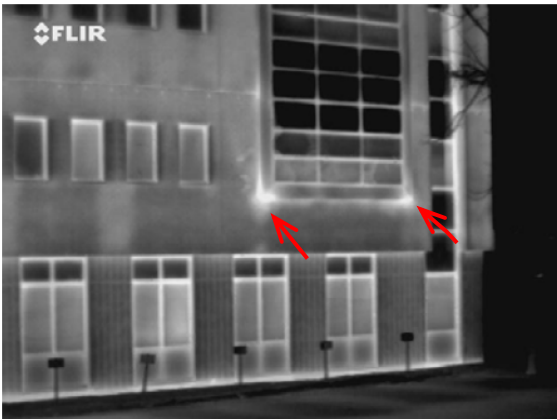
**Figure 6:** Air leakage noted at the bottom corners of the curtain wall assembly (building under positive pressure).

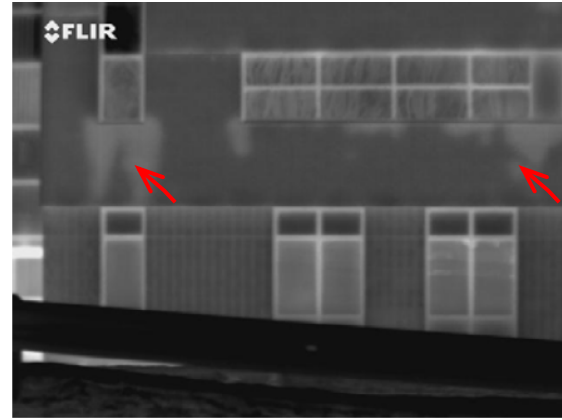
**Figure 7:** Moisture noted below the windows in the exterior masonry wall assembly (building under positive pressure).

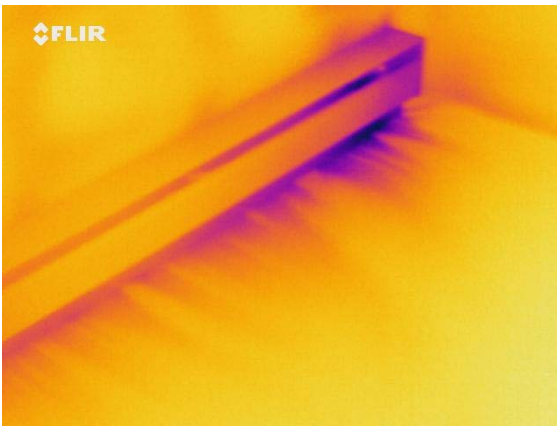
**Figure 8:** Air leakage noted below electric base board (building under negative pressure).

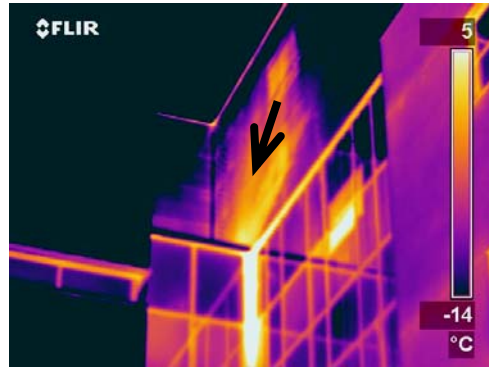
In this example, complaints of flies entering the building at the beginning of the first year heating season were reported by the building owner. A thermographic analysis of the building envelope was undertaken during the heating season. The building was pressurized by means of the building's mechanical systems and excessive air-leakage was noted at the top of several of the curtain wall assemblies (Figures 16 to 20).

**Figure 17:** Thermogram of the top portion of the CW assembly in figure 16.

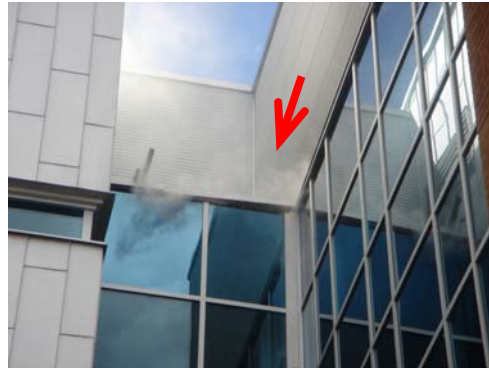
**Figure 18:** Subsequent smoke testing undertaken to determine and validate air leakage sources.

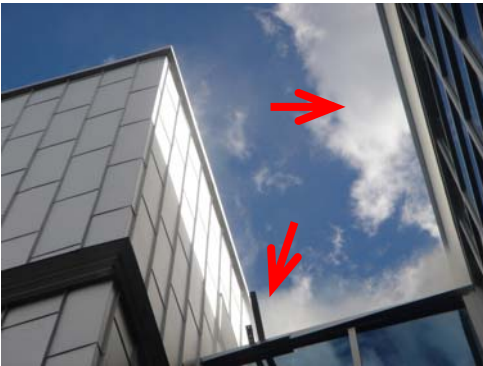
**Figure 19:** Excessive smoke exfiltration was clearly visible at the top portion of the CW assembly.

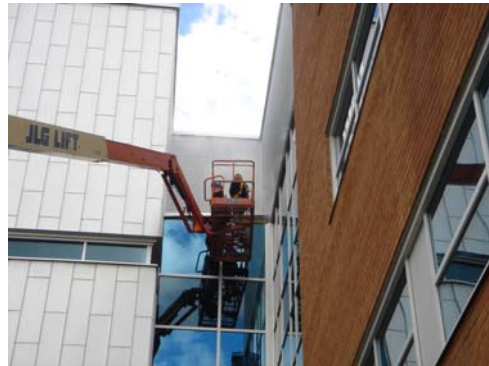
**Figure 20:** Dismantlement of the top portion of the CW assembly was undertaken to establish appropriate corrective measures.

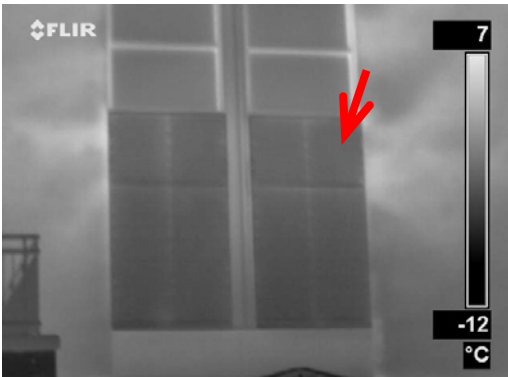
In this example, a thermographic analysis of the vertical building envelope was undertaken as part of the commissioning process of this new building construction. Several anomalies were identified, including excessive air leakage via the metal paneling below one of the curtain wall assemblies (Figures 21 to 24) and excessive moisture accumulation in the exterior masonry of part of the building (Figures 25 and 26).

**Figure 23:** Thermogram of bottom CW section with building under negative pressure.

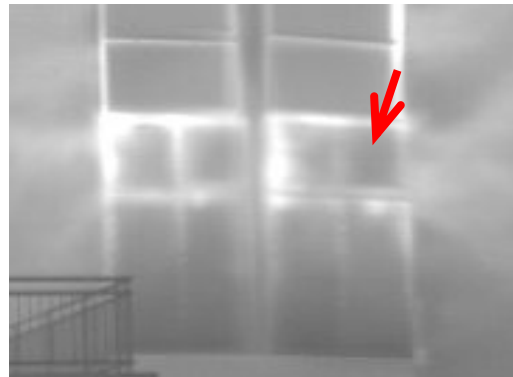
**Figure 24:** Thermogram of bottom CW section with building under positive pressure.

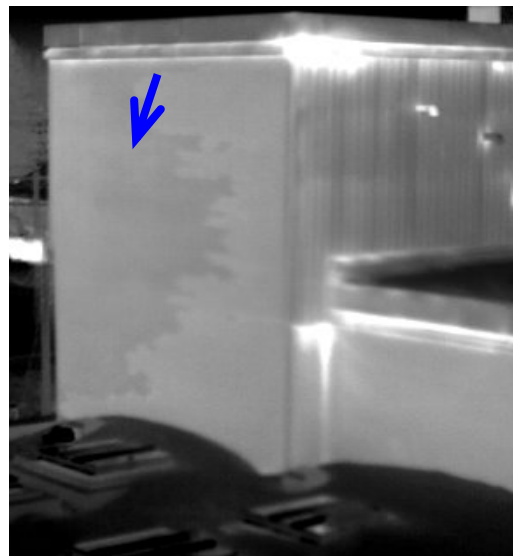
**Figure 26:** A large portion of the masonry wall assembly in figure 25 noted to contain moisture.

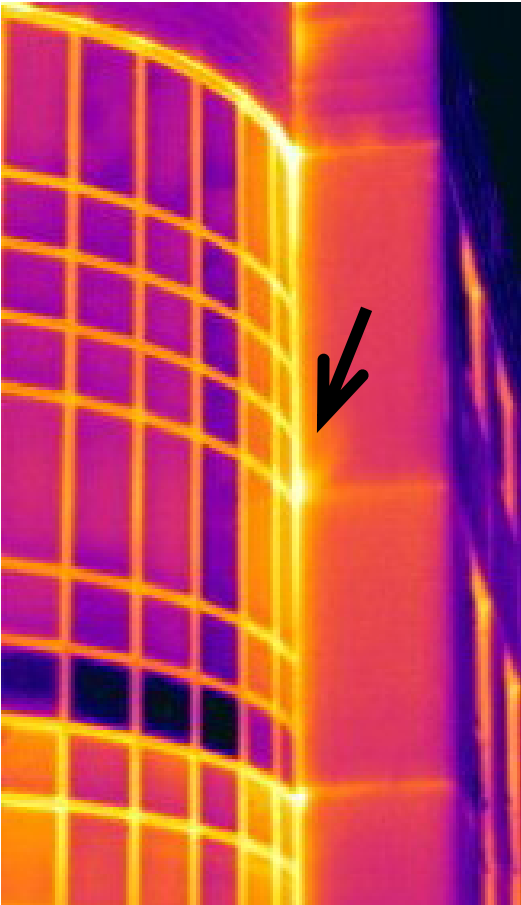
The interface detail between two different wall assemblies is a common source of air leakage and water infiltration problems. In these two examples, a thermographic analysis revealed excessive air leakage at the curtain wall interface with the adjacent masonry, requiring extensive remedial measures to correct.

**Figure 27:** First example thermogram of interface of curtain wall and masonry wall assembly.

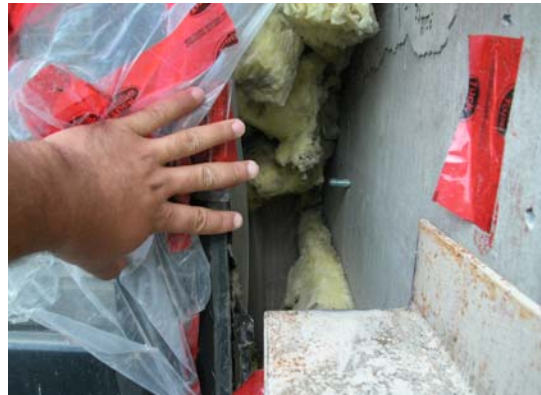
**Figure 29:** Close-up view of figure 28 - no air seal at the interface detail (the polyethylene sheet was installed as a temporary measure after removing the masonry).

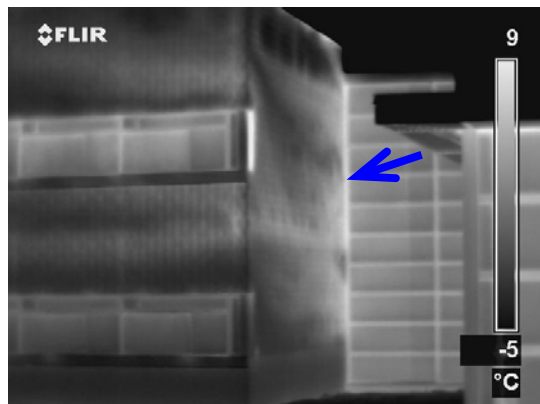
**Figure 31:** Thermogram reveals excessive air leakage at interface of curtain wall and masonry assembly shown in figure 30. Further investigation confirmed no air seal at the interface detail.
