Design Considerations for Curtain Wall Parapets in Cold Climates

Mario D. Gonçalves, Eng. ¹
Madeleine Z. Rousseau, B. Arch., M.Sc. ²

ABSTRACT

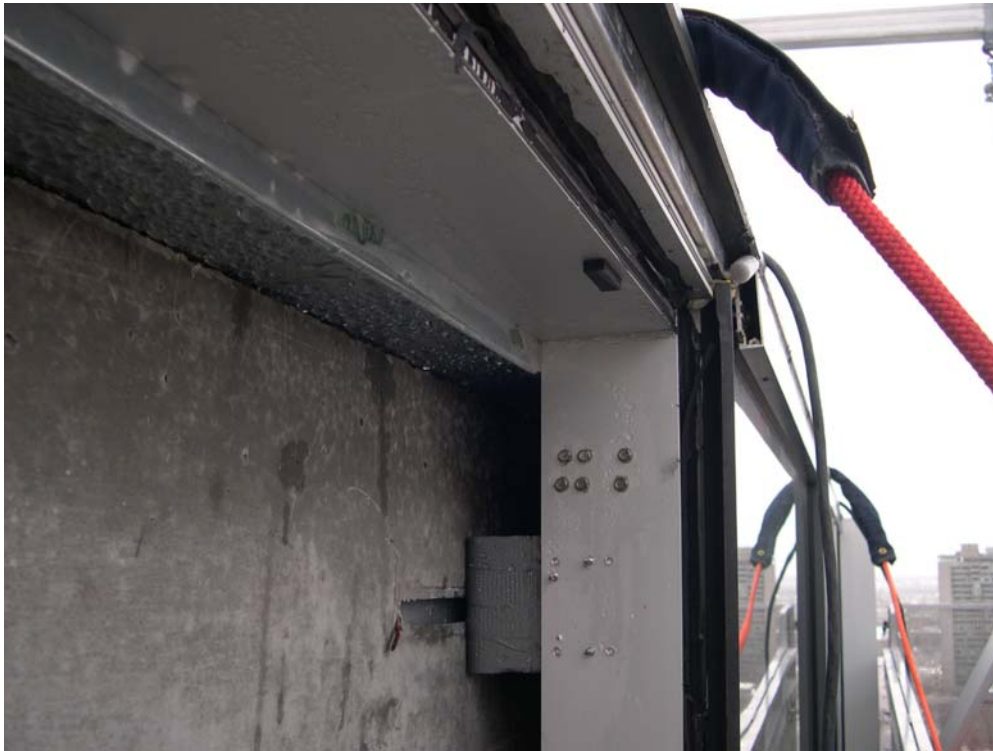
Figure 1: Condensation on curtain wall components behind insulated spandrel panel assembly.

Water infiltration problems due to condensation behind curtain wall parapet assemblies in cold climates is a recurring issue which often entails costly remedial repair measures. High parapets are particularly problematic given the difficulty in providing adequate air and heat circulation behind the curtain wall (for both stick built and unitized curtain wall systems). Condensation and frost build-up that form on the back side of the curtain wall components during cold exterior winter conditions (Figure 1) eventually thaw during warmer conditions, resulting in water dripping to the interior of the building and damaging the interior finishes. Left unattended, mold growth becomes a growing concern as well as potential long-term corrosion of the anchors at the top of the curtain wall.

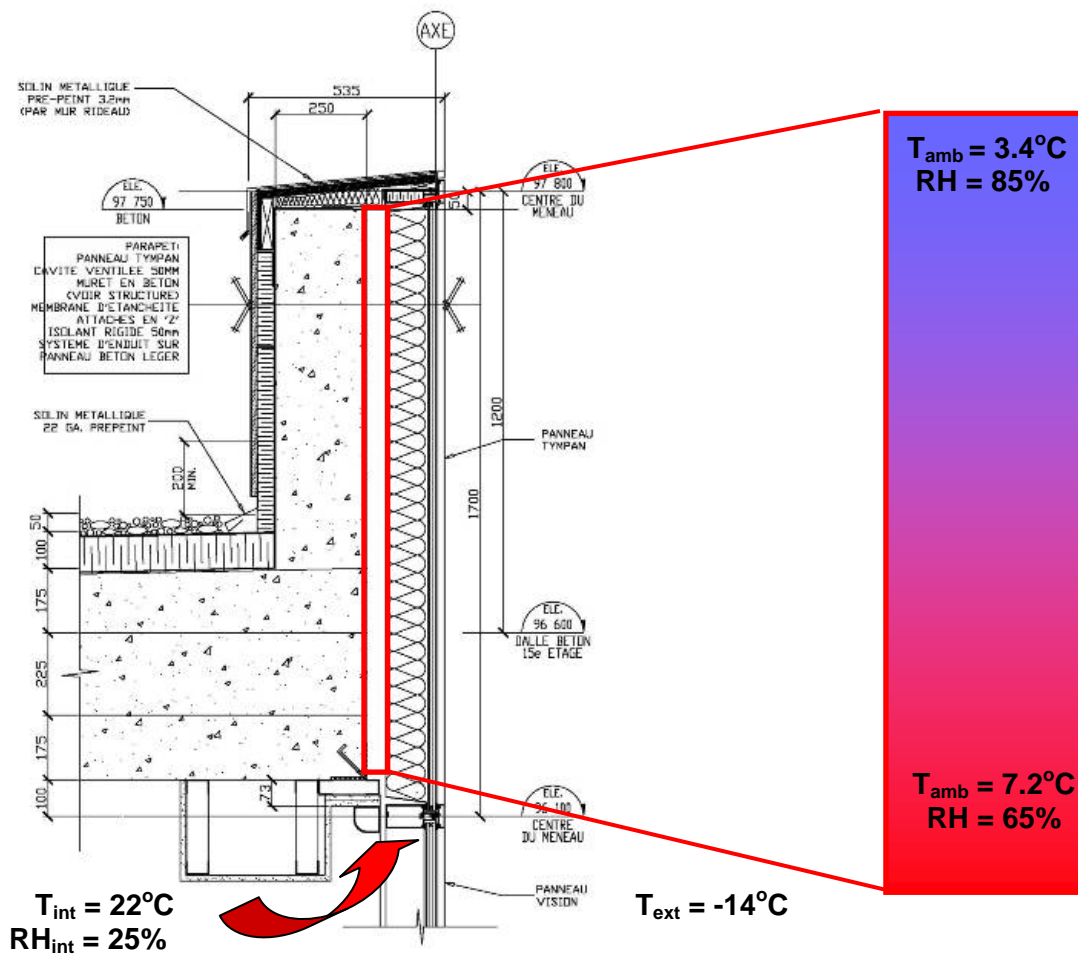
Figure 2: Air temperature and RH distribution behind a typical curtain wall parapet assembly.

It is common practice on metal and glass curtain wall buildings to continuously run the curtain wall upwards past the roof line to the top of the parapet level. The curtain wall at the top of the building is typically supported by a concrete or steel parapet structure and installed at approximately 25 to 50 mm in front of the edge of the floor slabs. Given that the exterior face of the parapet structure is usually in line with the exterior floor slab edge, the cavity between the back of the curtain wall and the parapet structure will be the same as the distance in front of the slab edge (between 25 to 50 mm). This cavity usually communicates with the interior ambient space and the air within the cavity will contain the same amount of moisture as the conditioned air in the interior of the building. However, given the limited width and more importantly the height of the cavity, natural heat flow is often insufficient to warm the back of the curtain wall during cold winter conditions. Condensation and frost formation occur when the surface temperatures of the curtain wall components which are in contact with the parapet air cavity are below the dew point temperature. The figure below (Figure 2) illustrates the measured ambient air temperature distribution within the air cavity of a typical 1.7 m high curtain wall parapet for an exterior temperature of -14°C .

The relative humidity distribution measured at the top and bottom of the air cavity behind the curtain wall is also illustrated in Figure 2. When comparing the relative humidity levels at the top and bottom of the cavity, it is important to note that the relative humidity level is a function of the ambient air temperature (ie. for the same amount of air moisture content, the relative humidity level will be higher when the ambient air temperature is lower). In practical terms, the higher the ambient air temperature, the more amount of moisture can be stored before reaching saturation. The figure below (Figure 3) provides a schematic illustration of the ambient interior and cavity air temperatures versus the corresponding relative humidity levels. In this example, the humidity ratio of the interior air and cavity air ($\text{kg}_{\text{air}} / \text{kg}_{\text{water}}$) are the same, which reflects the fact that the cavity between the back of the curtain wall and the parapet communicates with the interior ambient space and contains the same amount of moisture as the conditioned air in the interior of the building. The dew point temperature will therefore be same when calculated at either of the two conditions, as illustrated in the psychrometric chart below (figure 4).

In order to measure the surface temperature of the curtain wall components exposed to the conditioned air cavity in the example presented in figure 2, thermocouples were installed on the backside of the insulated metal pan, mullions, anchors and other miscellaneous curtain wall components. This was accomplished by removing a typical spandrel and back pan assembly at the parapet level and its subsequent reinstallation following installation of the thermocouples.

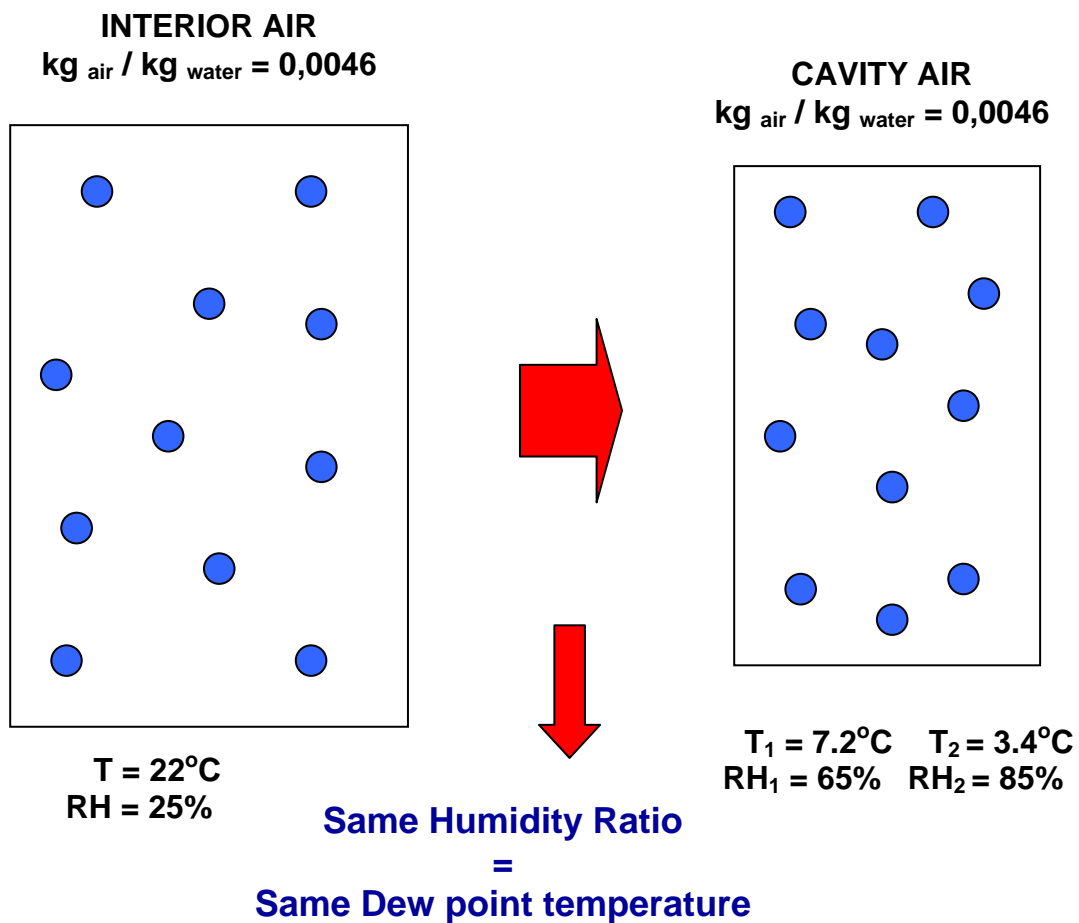
Figure 3: Illustration of ambient temperature versus relative humidity levels.

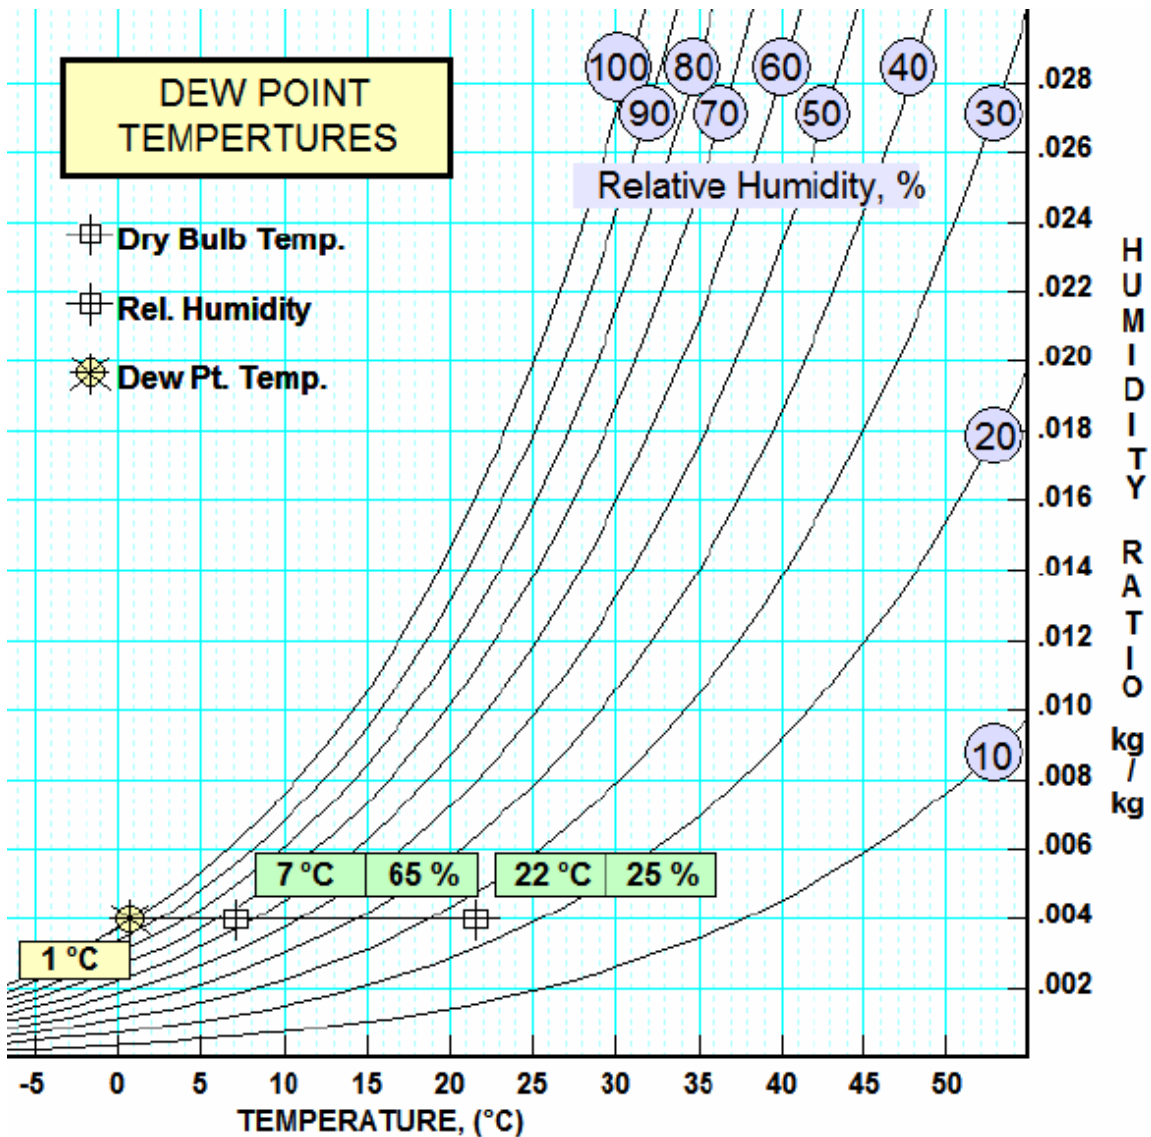
Figure 4: Psychrometric chart.

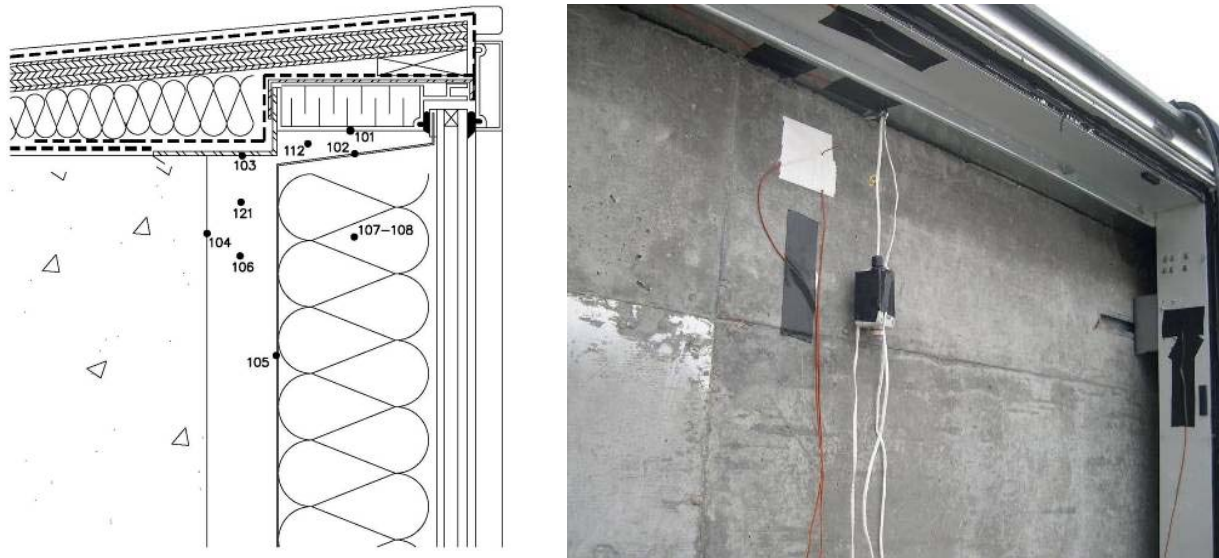
Figure 6: Thermocouples installed on back of curtain wall components.

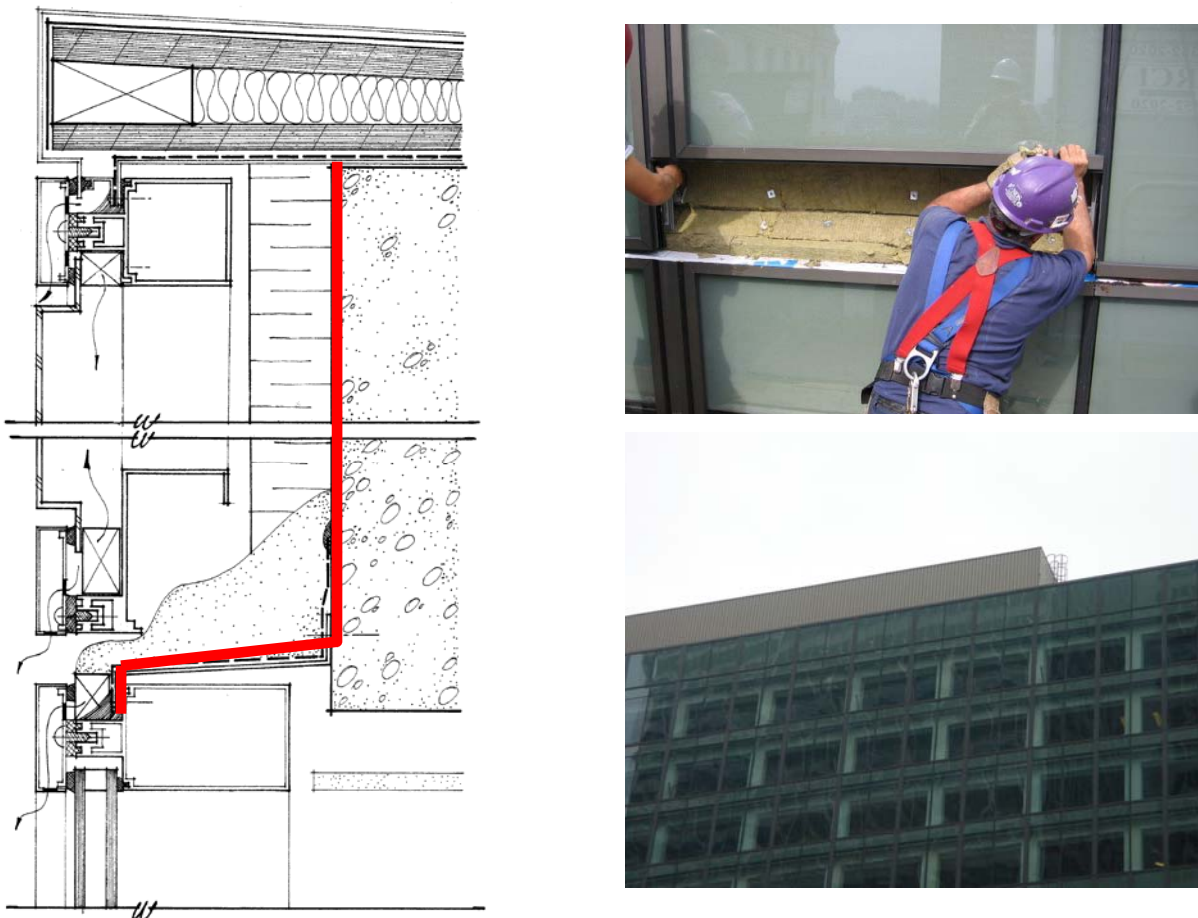
Figure 8: Curtain wall interrupted and sealed below the parapet level.

A practical alternative is to stop and seal the curtain wall below the parapet level as illustrated in the figure below (figure 8). In order to achieve the architectural look of a continuous curtain wall, the parapet level is “clad” with a small curtain wall section. The section of curtain wall cladding at the parapet level can be designed to match the rest of the curtain wall and the spandrel area can be comprised of glass, metal or any other material typically used in curtain walls.

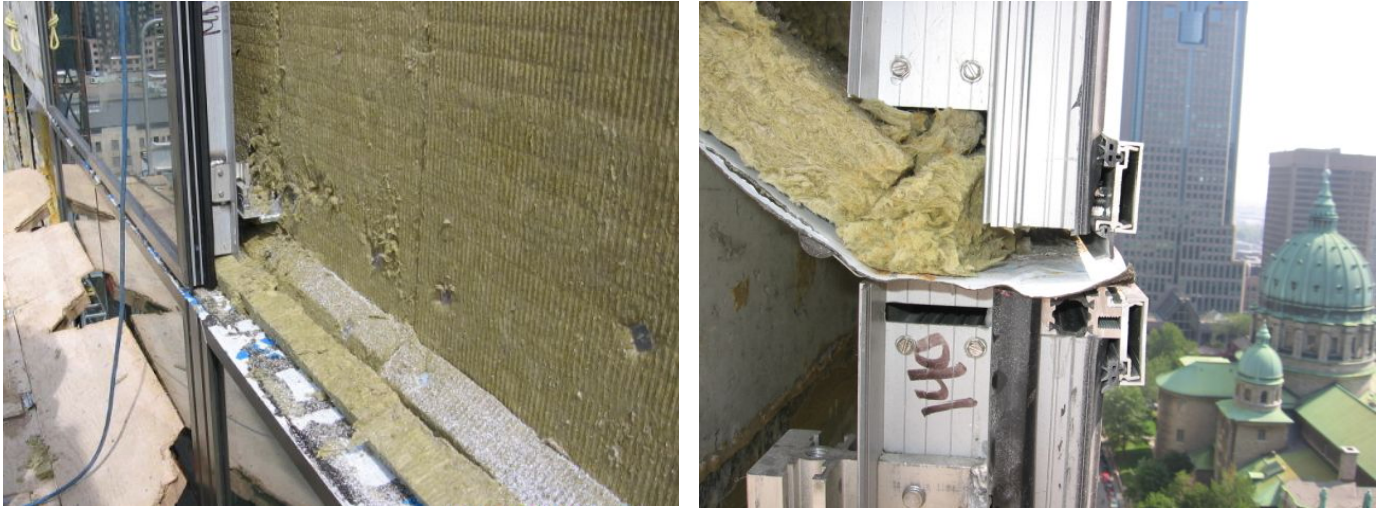
Figure 9: Curtain wall cladding at parapet level.

In this application, it is essential to ensure the continuity of the air barrier and thermal barrier at the top of the curtain wall termination, which shall be extended behind the curtain wall parapet cladding and tie into to the roof assembly system. Once this has been completed, the curtain wall parapet cladding is installed. The parapet cladding is vented and drained to the exterior, much like in a conventional rain screen wall construction

This alternative approach to curtain wall parapet construction eliminates the cavity behind the back of a typical curtain wall parapet which usually communicates with the interior ambient space, resulting in condensation and frost formation during cold winter conditions. When incorporated in the design phase, this approach is efficient, cost effective and easy to undertake.
