## A Global Strategy in Evaluating Building Roof Performance and Diagnosing Moisture Intrusion into Roofing Systems Using Infrared Thermography and Other Diagnostic Tools

*Pierre Gendron, senior thermographer  
Patenaude-Trempe Inc.*

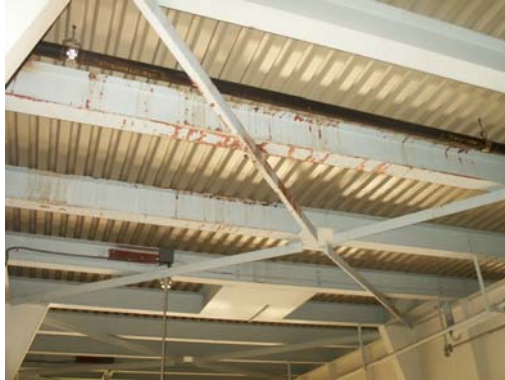
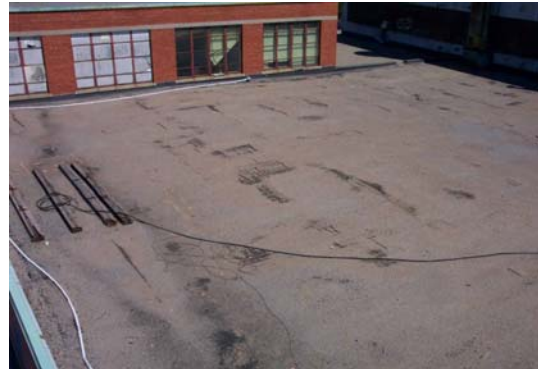
*Figures 2 and 3. Photos showing signs of water ingress below roof deck (at left) and signs of roof membrane deterioration above*

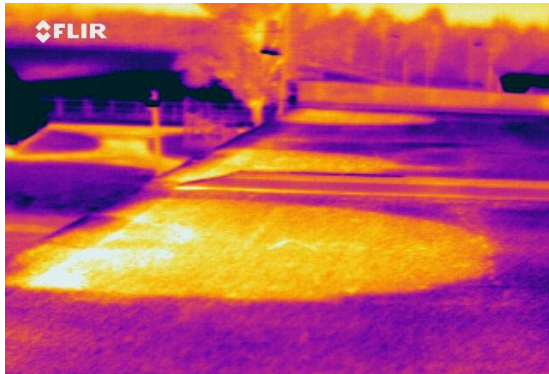
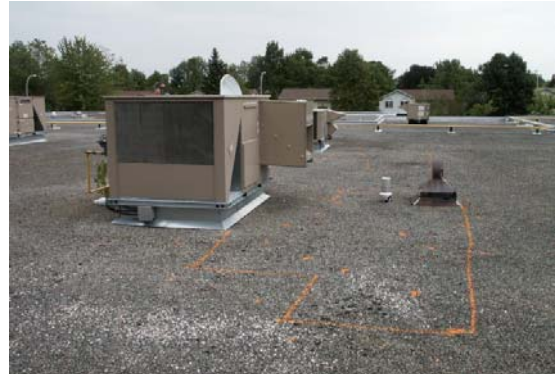
Figures 6 and 7. Typical infrared scan of wet area within roofing system at left. At right, paint typically used on roof surface to delineate suspect area of roofing system.

During the infrared scan of the roofing system, the suspect areas are often delineated with spray paint applied directly on the surface of the roof membrane. These areas are measured and then transferred onto plan drawings of the roofing system as part of the recording process. Often depending on the geometry of the building, up to several hundred thousand square feet of roof area can be scanned during one evening until which time the thermal signature from the roof membrane above the wet locations stabilizes with that of the surrounding roof membrane and the signal is no longer detectable.

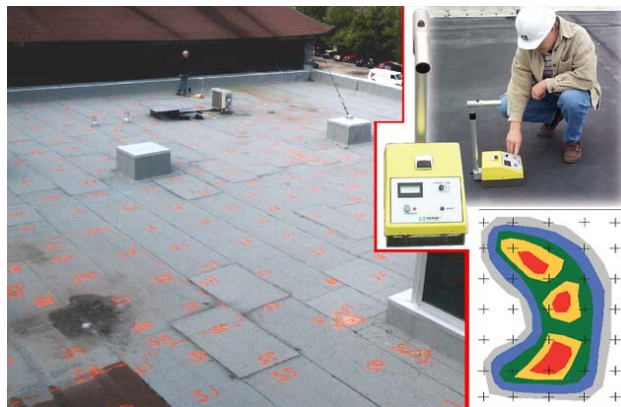
*Figures 9 and 10. Use of nuclear meter used to detect moisture in the roofing system.*

The **nuclear meter** used for roofing assessments is specifically designed for performing roof moisture surveys. Its calibration differs from the nuclear density meters used to measure in situ soil moisture. A roof moisture gauge sends a cone of fast neutrons into the roof. The neutrons bounce off materials in the roof and some return to the sensor located inside the nuclear device (see figure below). The speed of the neutrons is slowed if they come into contact with hydrogen atoms. Typically the presence of hydrogen atoms in roofing systems is due to the presence of water ( $H_2O$ ) within the roof composition. The sensor within the nuclear moisture meter detects and displays an appropriate reading when the neutrons are slowed by hydrogen atoms within the roof system and consequently is able to confirm water presence within the roofing system. Other roofing materials may also contain hydrogen atoms and therefore must be differentiated from the hydrogen atoms contributed by the presence of water. Usually readings are taken on a 5' by 5' foot grid marked directly on the roof surface.

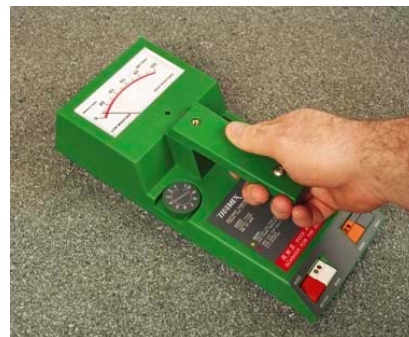
*Figures 11 and 12. Use of a capacitance meter used to detect moisture in the roofing system.*

A **capacitance meter** creates an alternating current electrical field in the materials below it (see figure below). The ability of those materials to store and dissipate electrical energy is related to their dielectric properties. The dielectric properties of water are significantly different from those of roofing materials. The dielectric constants of most materials used in roofing range from 1-4, whereas the dielectric constant of water is 80.

Numerical readings are obtained at grid points about 5 feet apart. Capacitance meters are quite sensitive to moisture just below their base. It is essential that the surface of the membrane and any gravel on it be dry when readings are taken. The presence of a small amount of water within the plies of a bituminous built-up membrane will be noted easier with a capacitance meter than a nuclear meter or infrared camera.

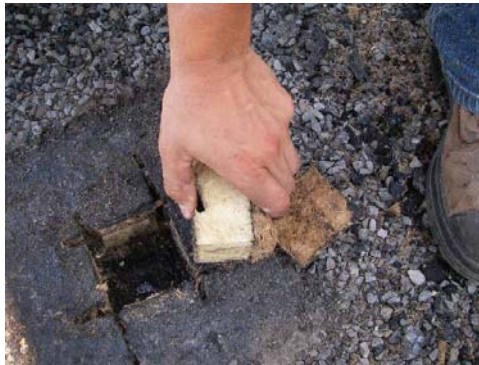
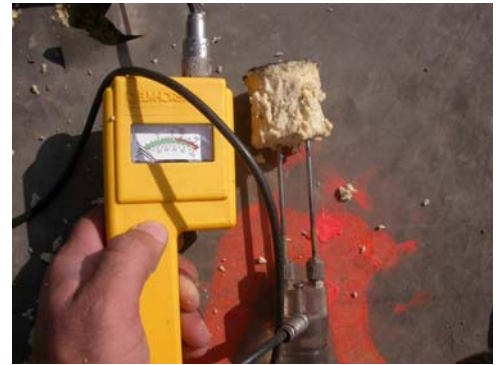
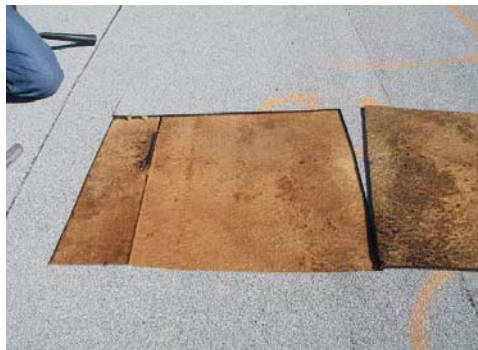
*Figures 13, 14, and 15. Exploratory openings executed in roofing system to confirm roof composition, to validate results of infrared thermography study, and to determine actual location of moisture within the roof components.*

Despite the advancements and benefits provided in moisture detection equipment such as infrared thermography, nuclear meters, and capacitance meters, over large areas, exploratory openings in select locations in the existing roofing system is nonetheless required to provide final confirmation and validate the results obtained from the non-destructive assessment of the roofs. In addition the exploratory openings provide confirmation of the actual roof composition. The exploratory openings, which vary in size, are executed in a few select areas where moisture detection equipment has registered possible moisture within the roofing system, as well as in areas where moisture was not detected. These openings also help to confirm the depth at which moisture is imprisoned in the roofing system or within the plies of the roofing membrane. An experienced roofer should be mandated to execute the required openings and subsequent repairs under the supervision of the roofing professional. In cases where the roofing system is still within the warranty period, the exploratory openings and repairs should be executed by the same roofer who is providing the warranty in order not to risk nullifying the roof warranty.
